Manhole Inspection Summary

Manhole # **S43CC_045MH**

Insp Date: **1/8/08 12:07 PM**

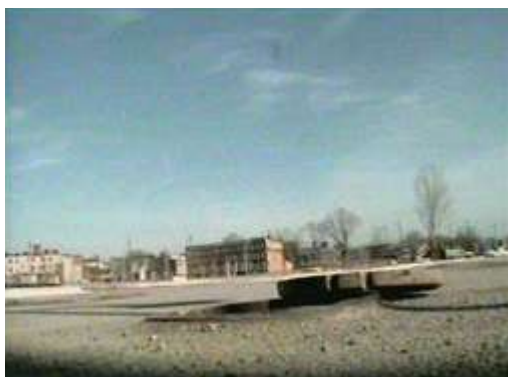
Defect 1

cover above pavement

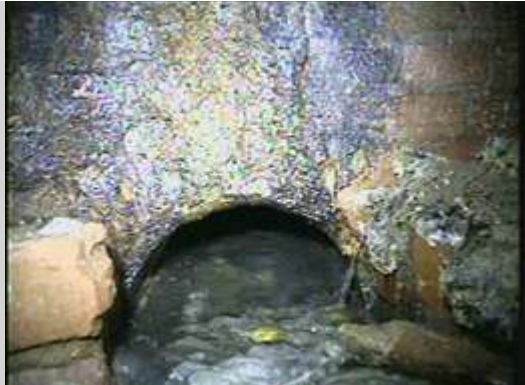
12 O'Clock Outflow

8 in. Circular Gravity Sewer
Pipe Out @ 12 O'Clock

Deposits: ☐ None ☐ Mud ☐ Sludge ☒ **Debris** ☐ Grease

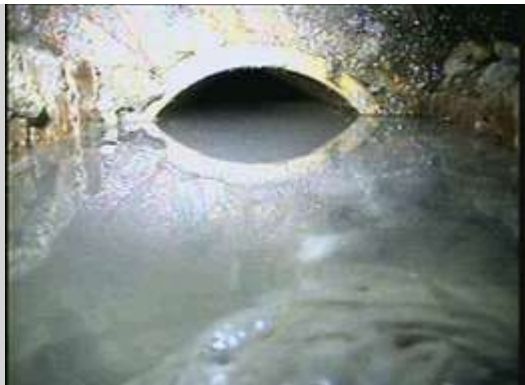
3 O'Clock Inflow

8 in. Circular Gravity Sewer
Pipe In @ 3 O'Clock
